NASA Technical Memorandum 86347

**DIRECT-STRIKE LIGHTNING PHOTOGRAPHS,
SWEPT-FLASH ATTACHMENT PATTERNS,
AND FLIGHT CONDITIONS FOR
STORM HAZARDS '82**

**Klaus P. Zaepfel,
Bruce D. Fisher,
and Merle S. Ott**

February 1985

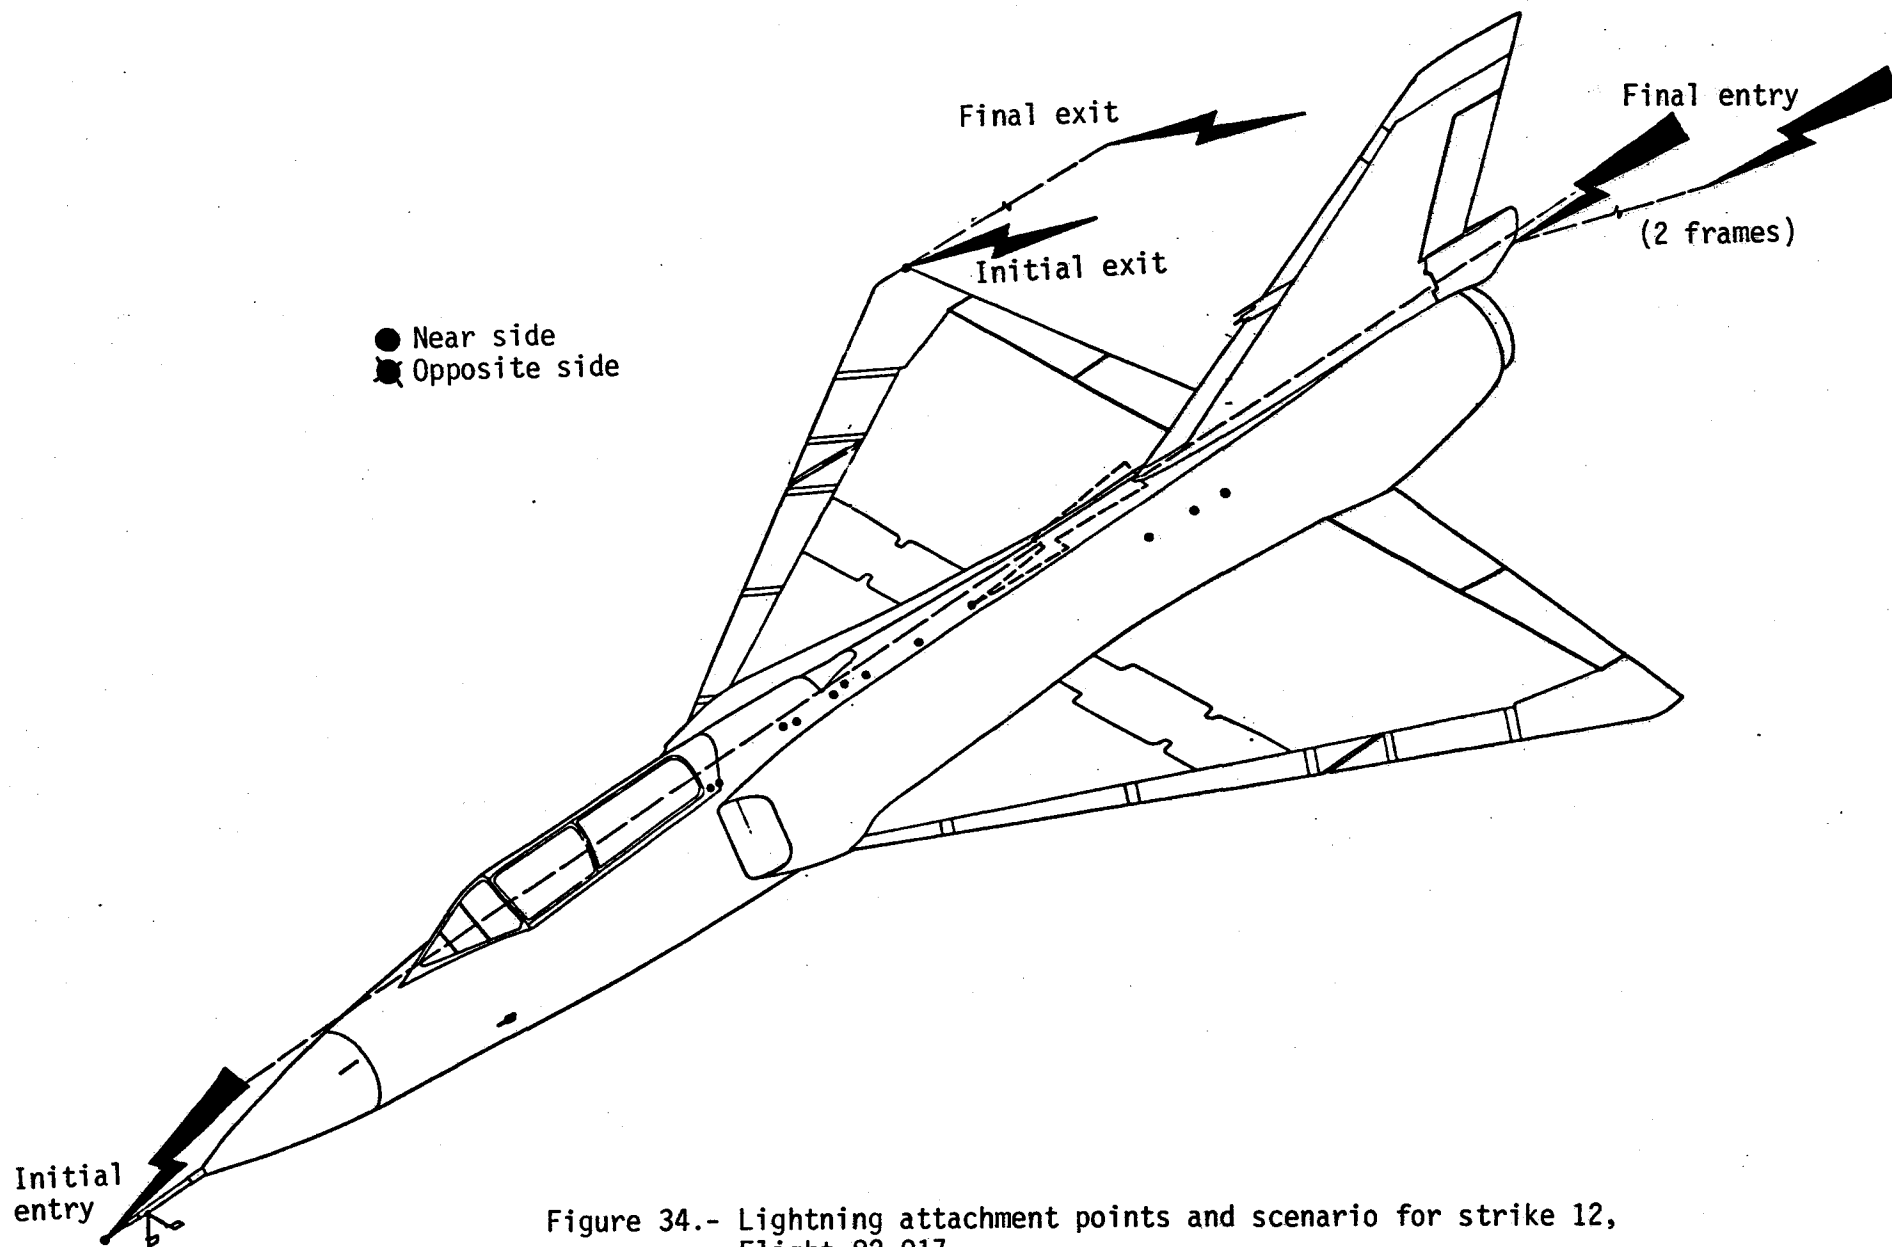
Figure 34.- Lightning attachment points and scenario for strike 12, Flight 82-017.

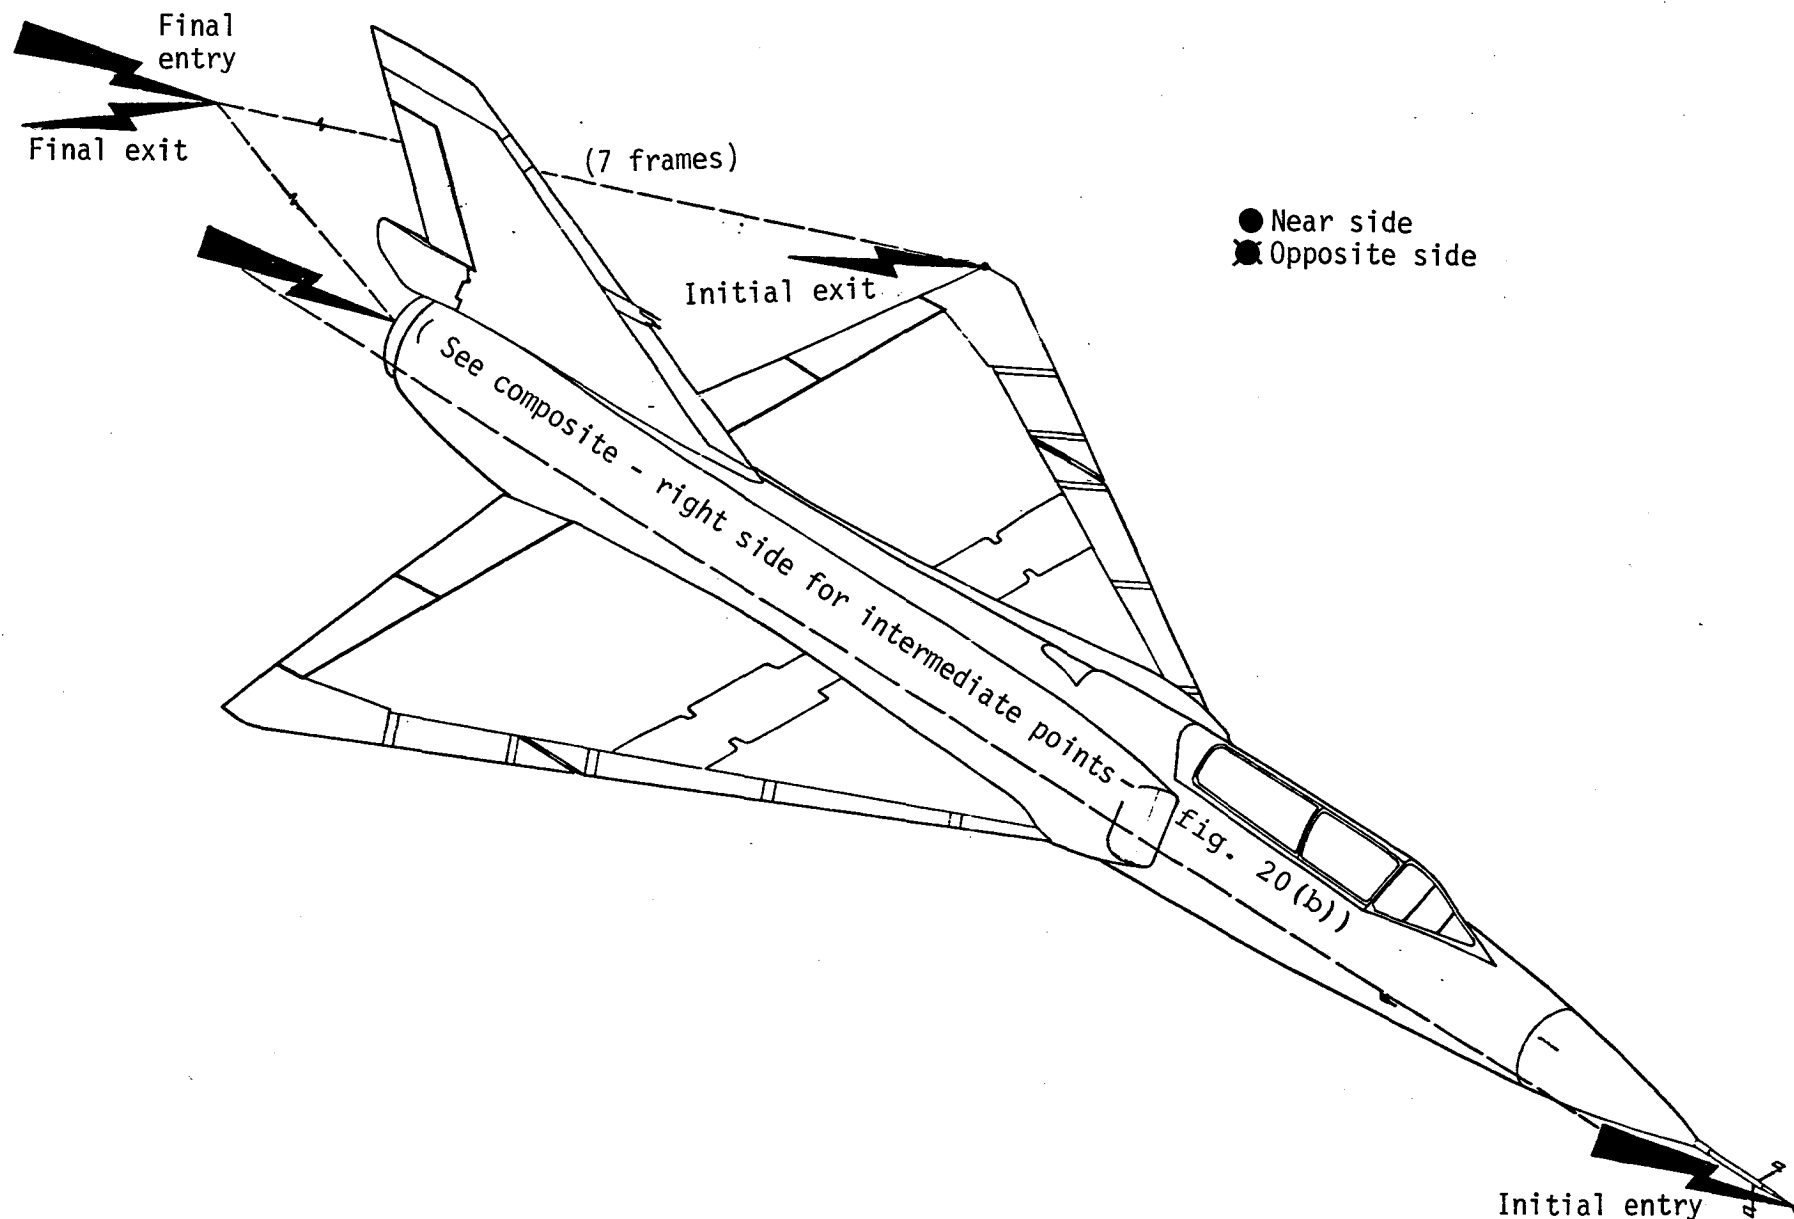
Figure 37.- Lightning attachment points and scenario for strike 13, Flight 82-017.

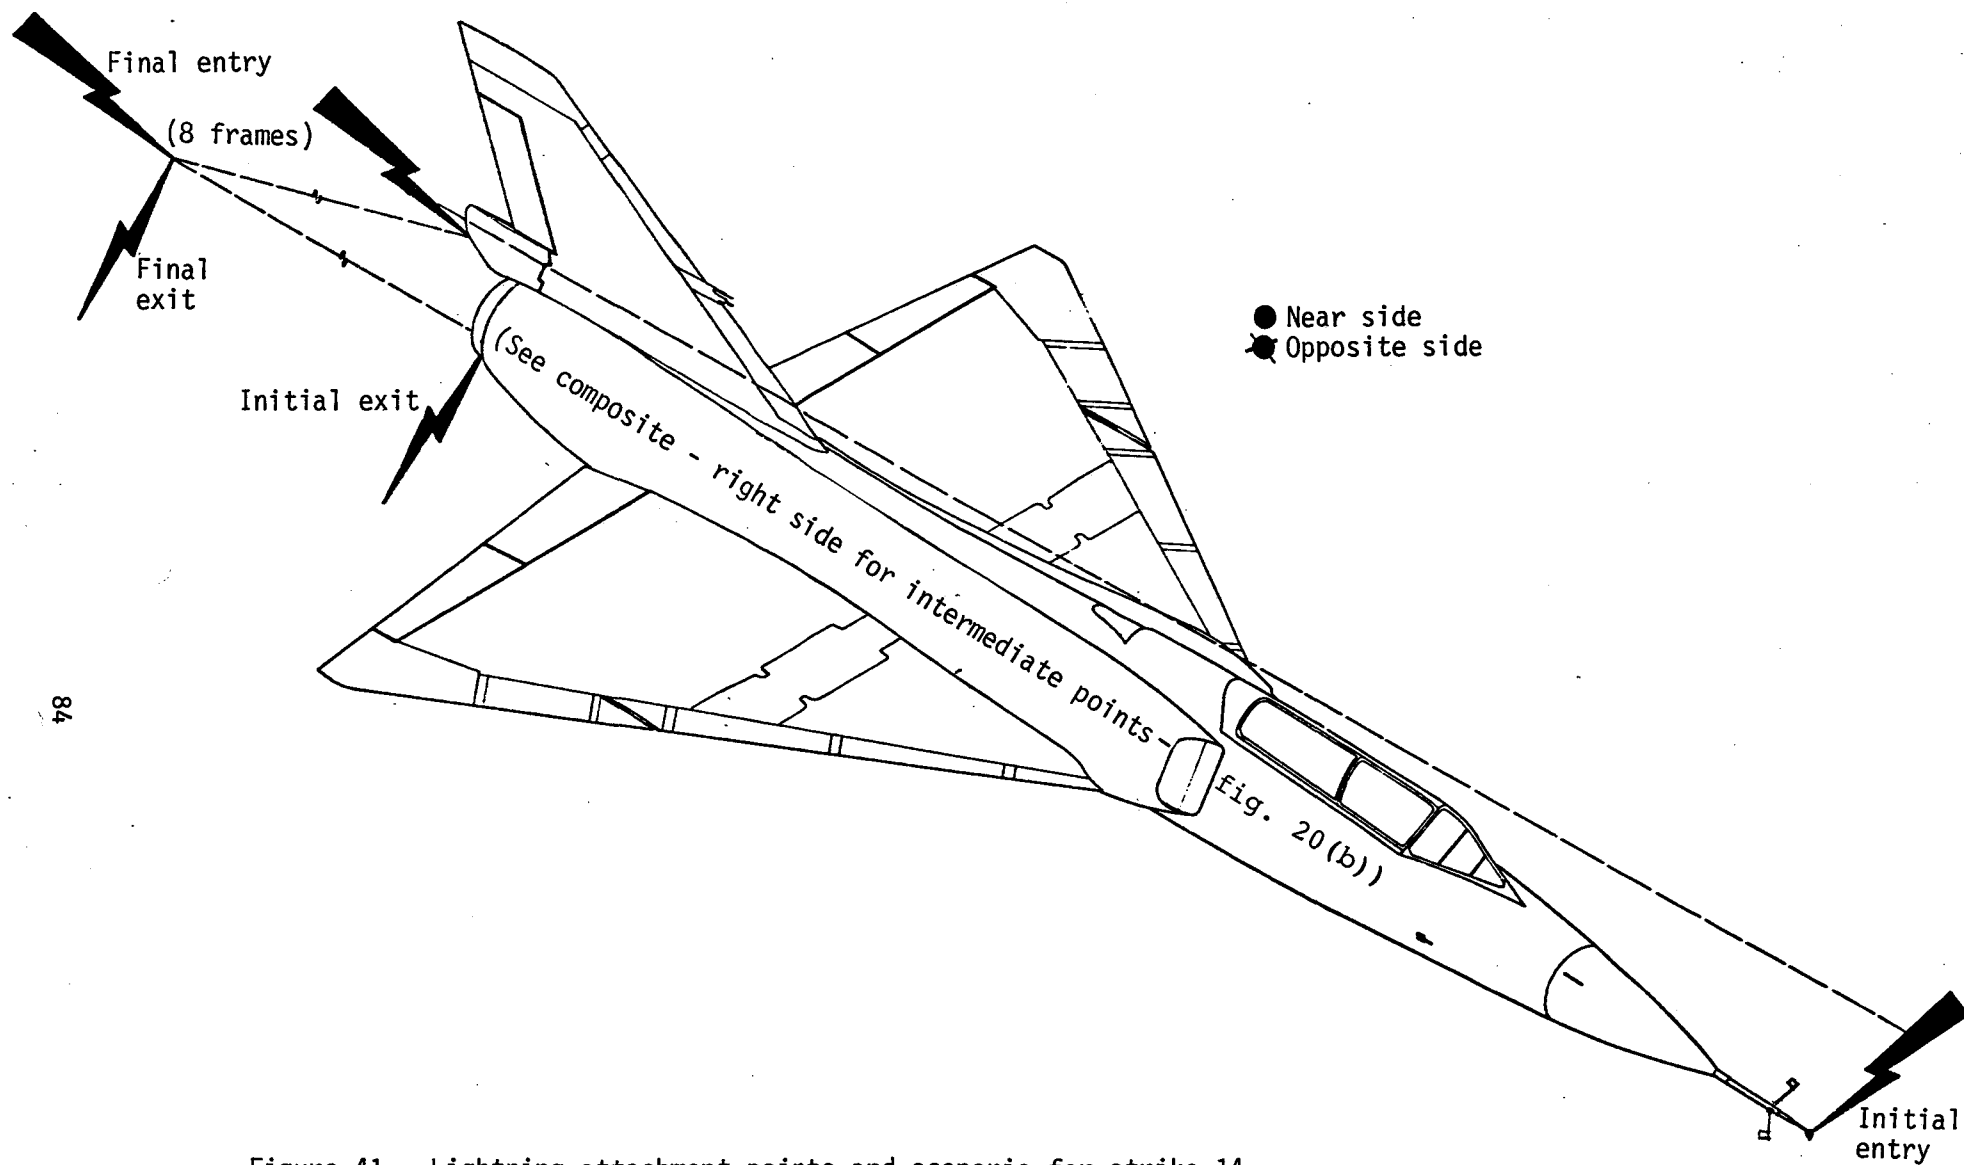
Figure 41.- Lightning attachment points and scenario for strike 14, Fight 82-017.

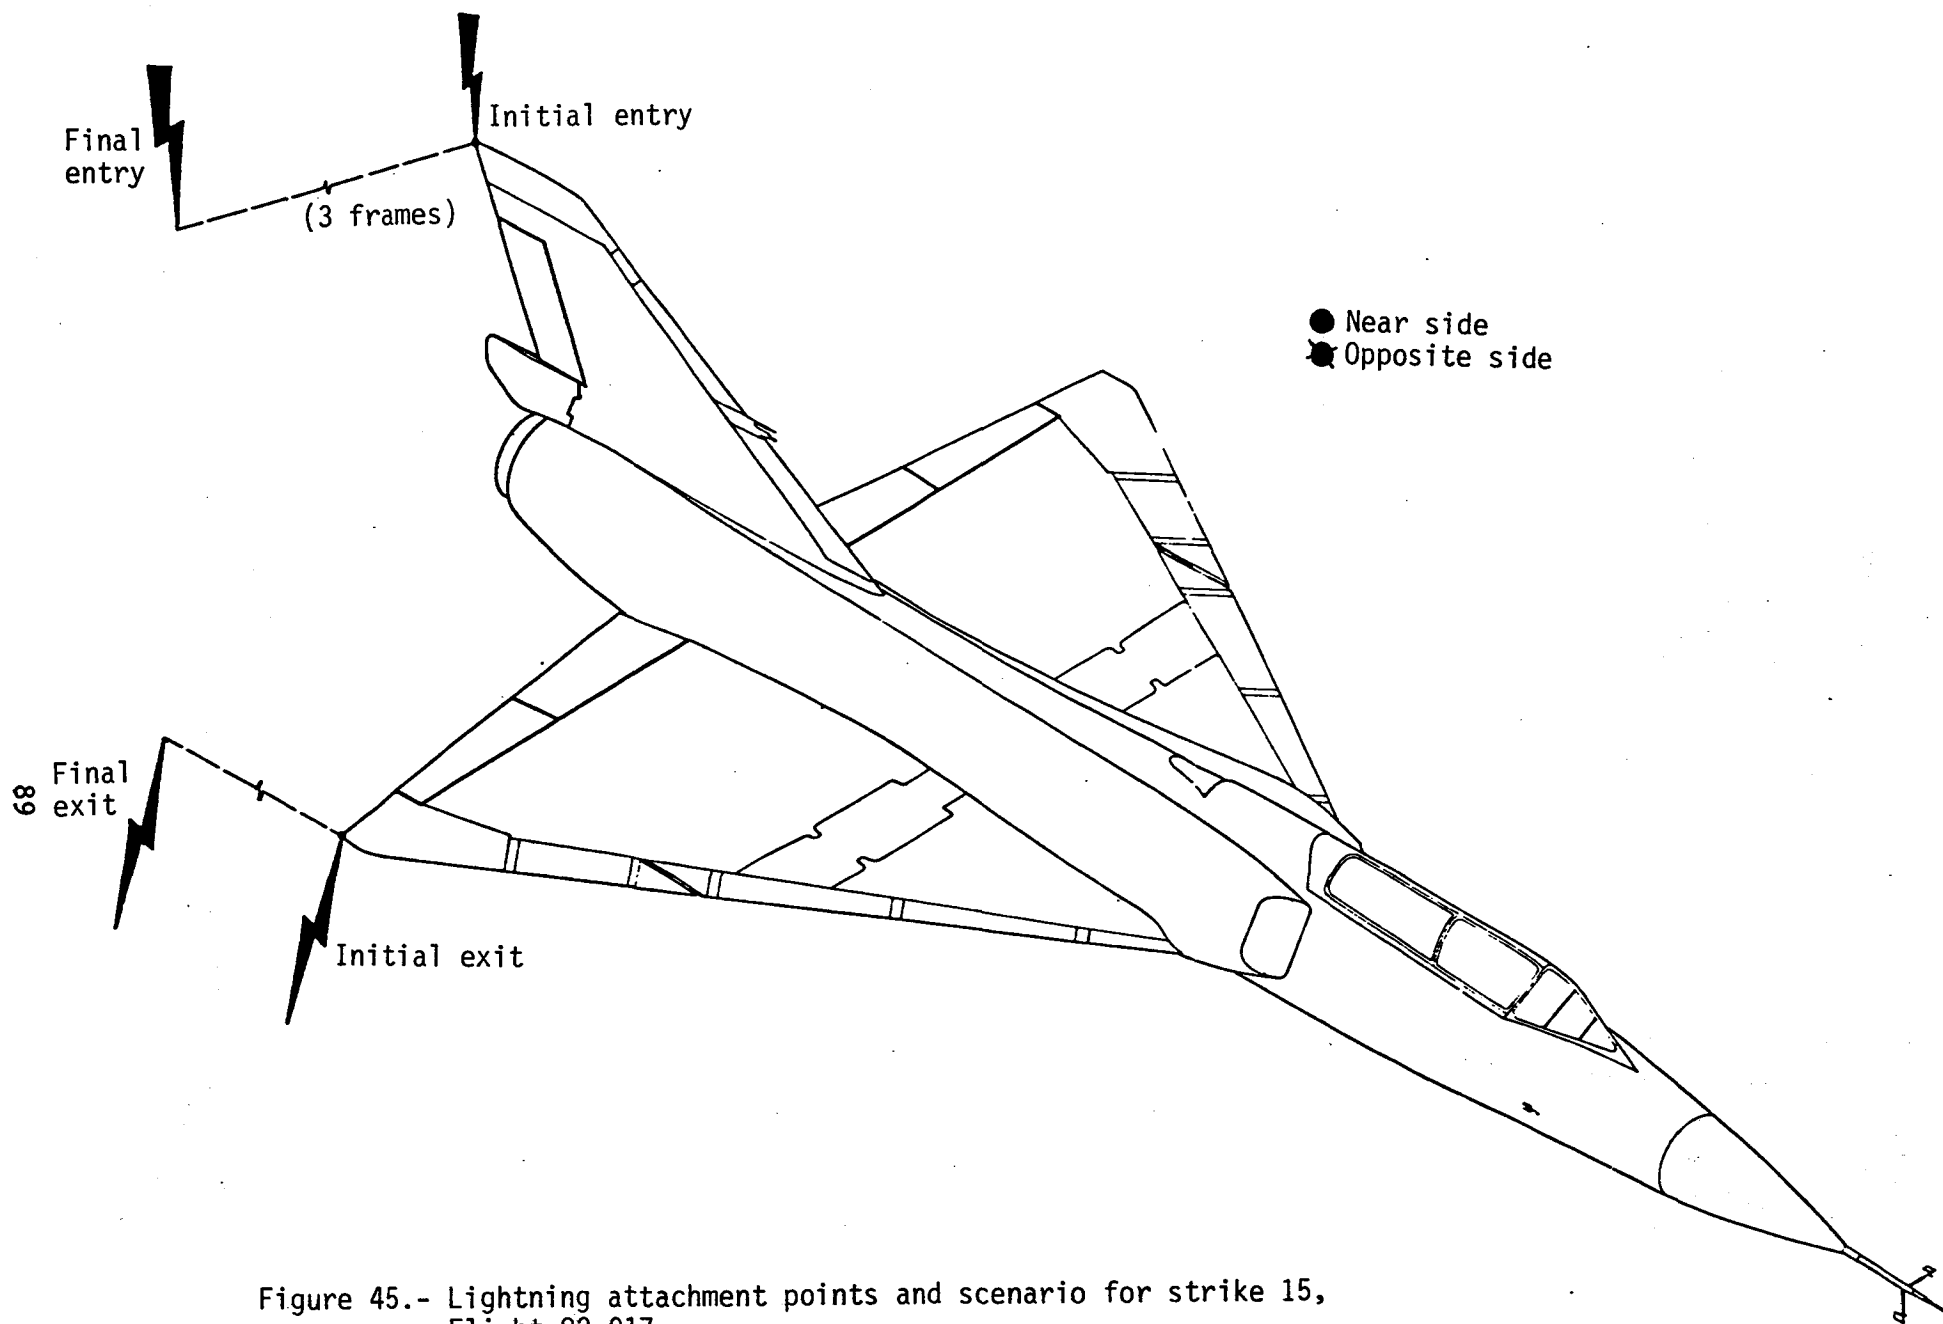
4. Strikes in which the initial and final entry and exit points are confined to the aft extremities, as shown in figures 20, 45, 46, and 47 (strike 15 of 1982). About one-third of the strikes to date have demonstrated this pattern.

Figure 45.- Lightning attachment points and scenario for strike 15, Flight 82-017.

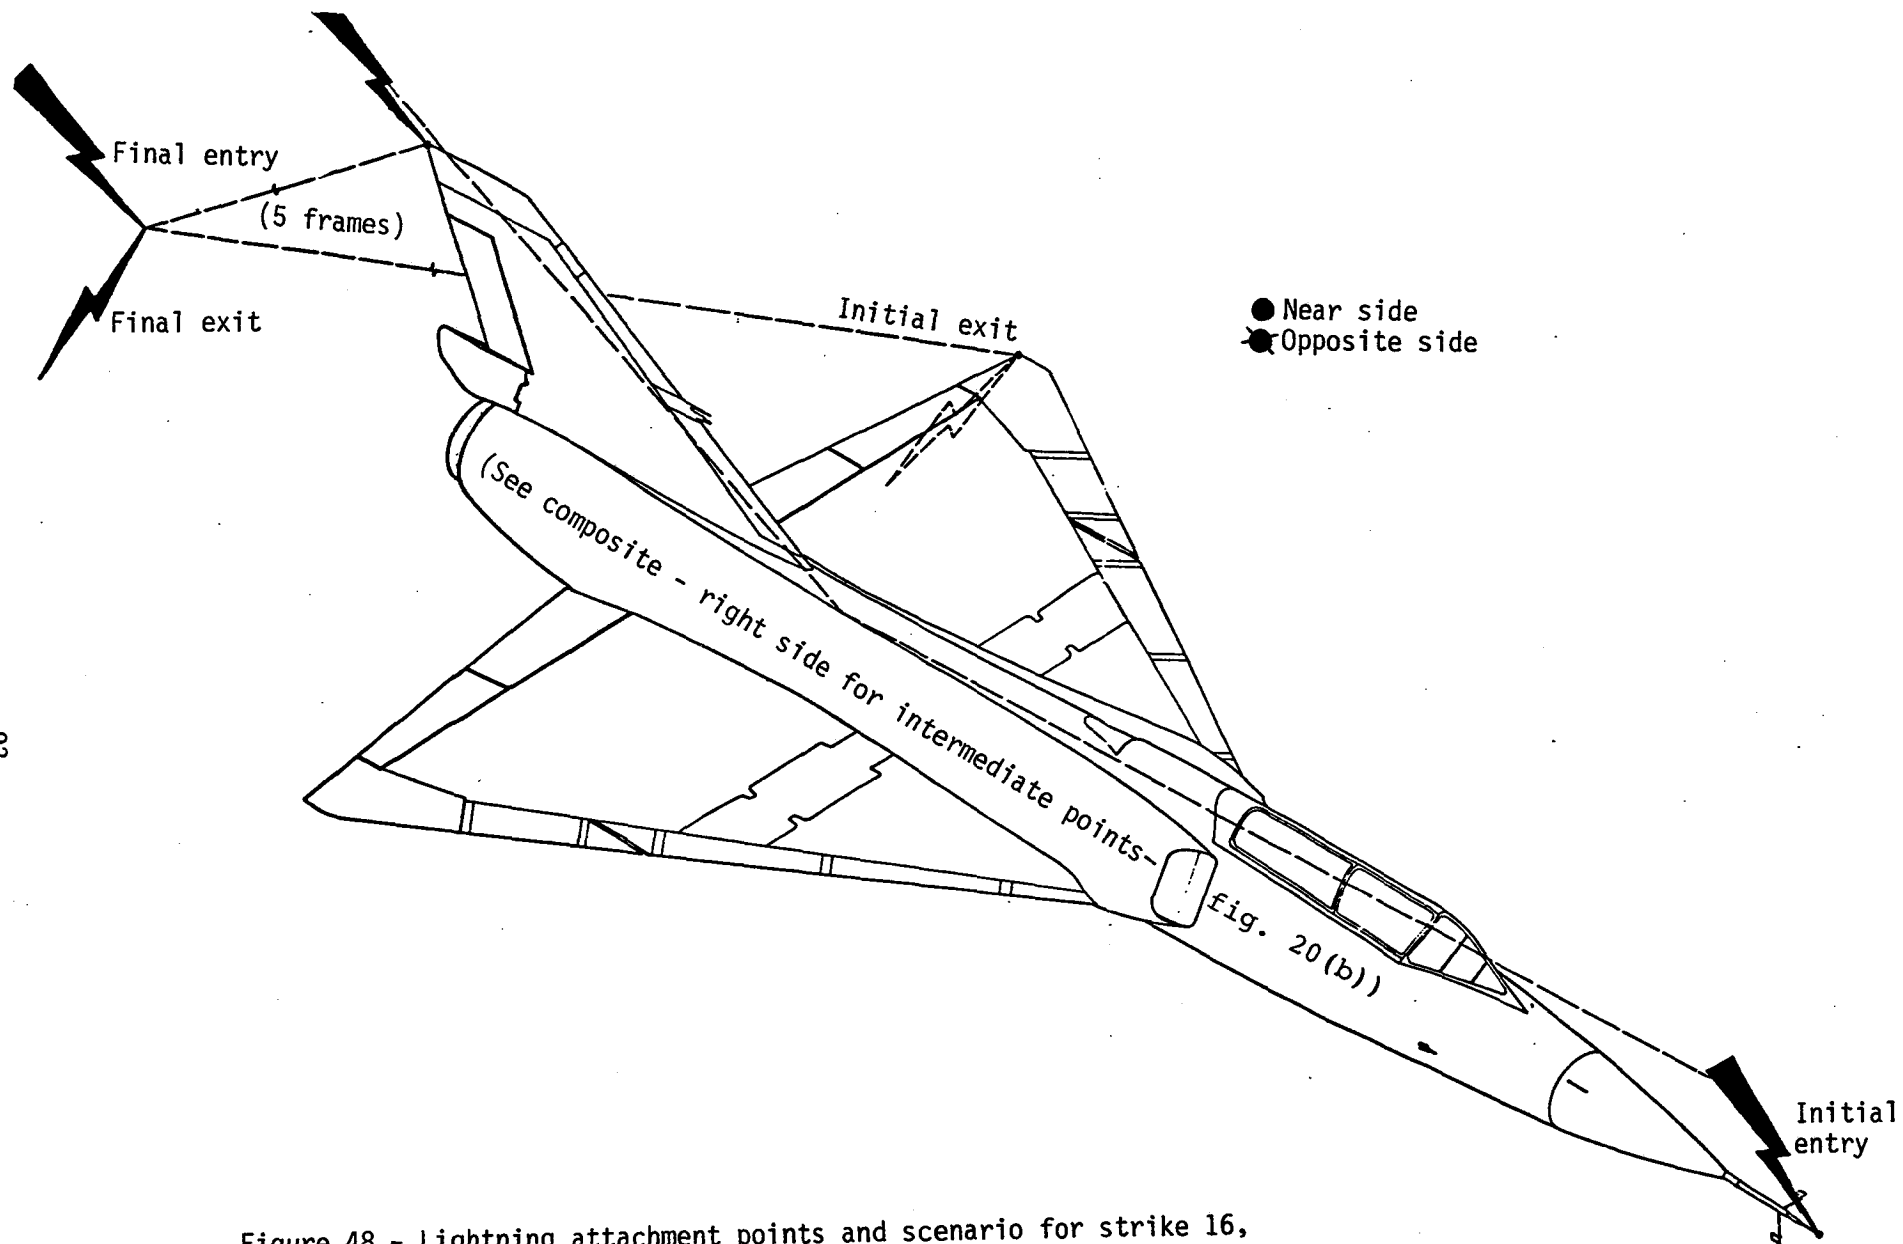
Figure 48.- Lightning attachment points and scenario for strike 16, flight 82-017.

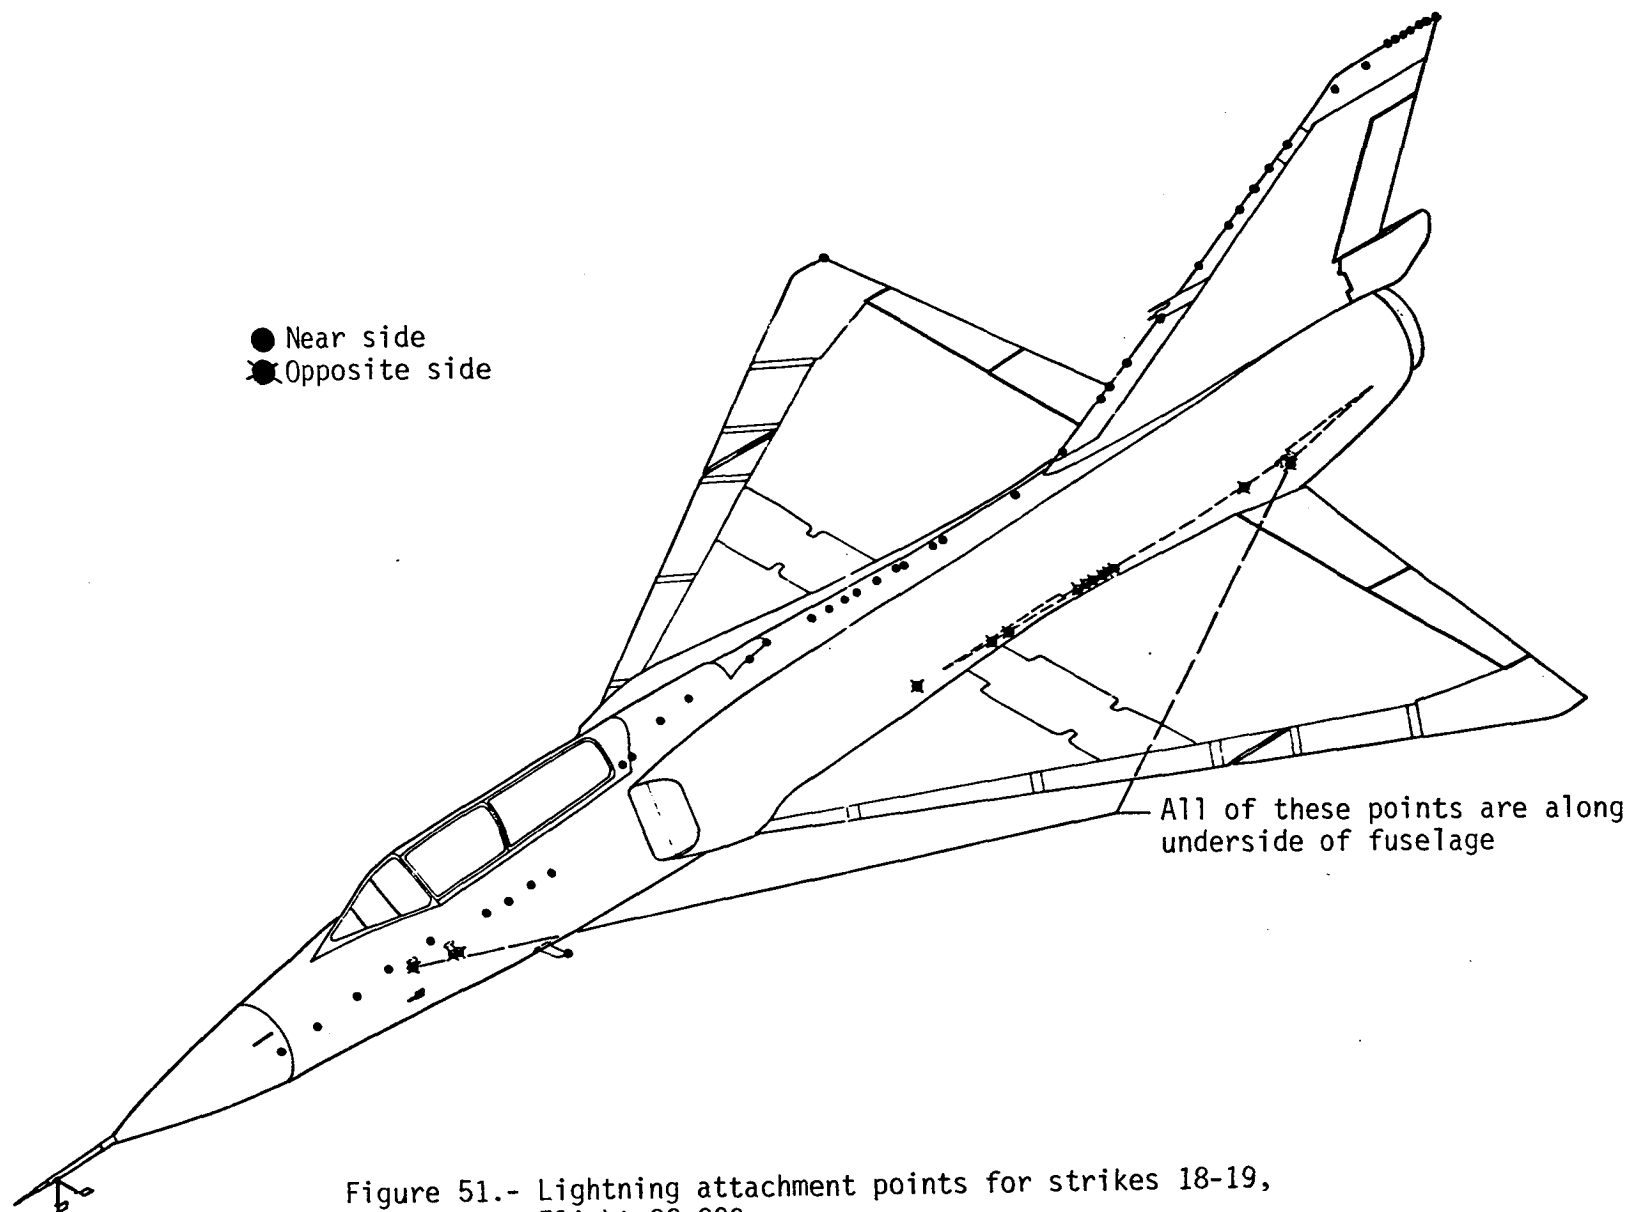
Figure 51.- Lightning attachment points for strikes 18-19,
Flight 82-020.

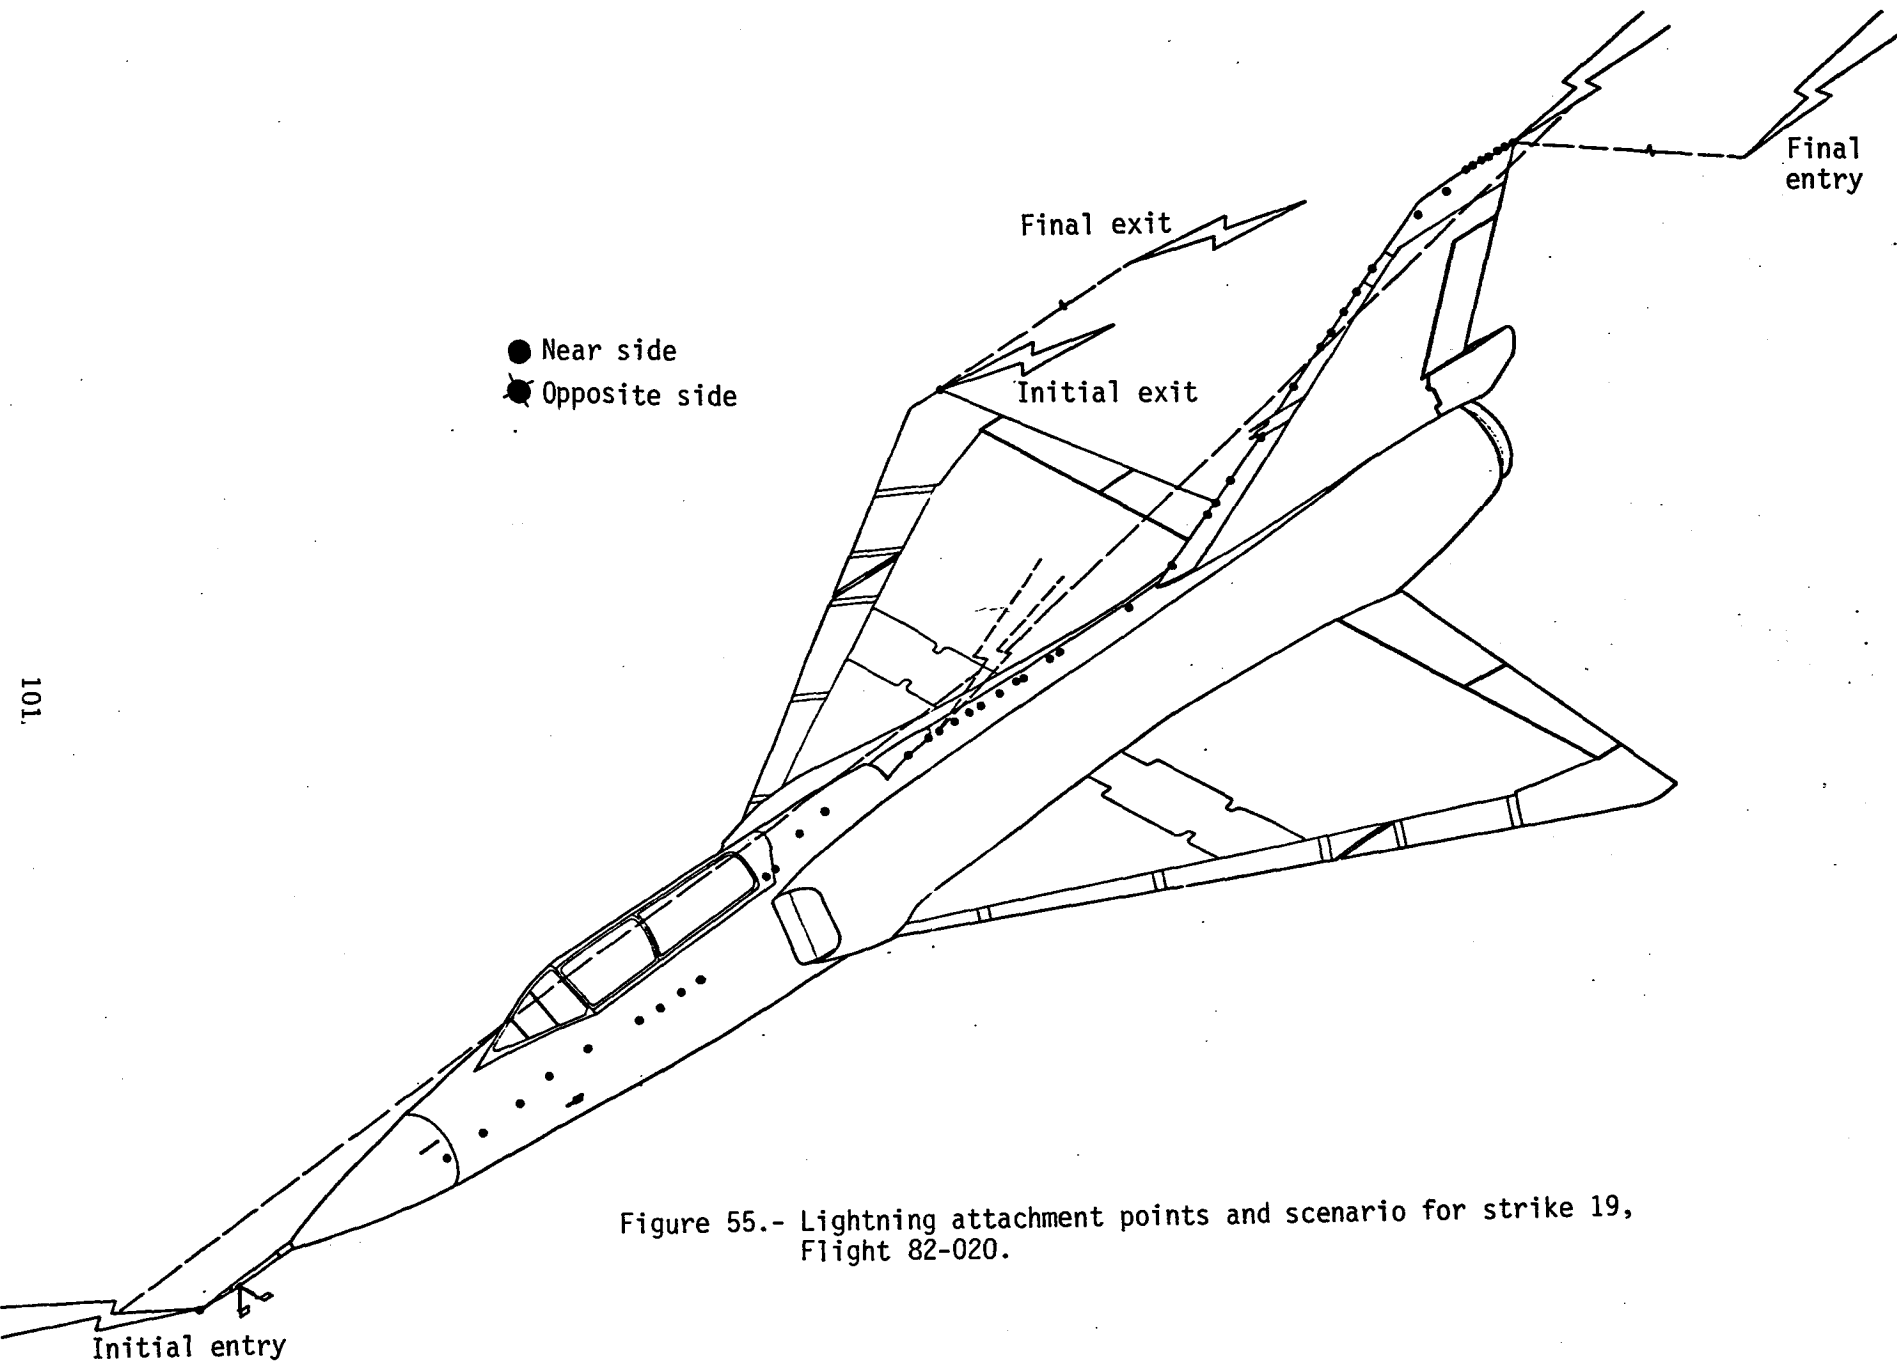
Figure 55.- Lightning attachment points and scenario for strike 19, Flight 82-020.

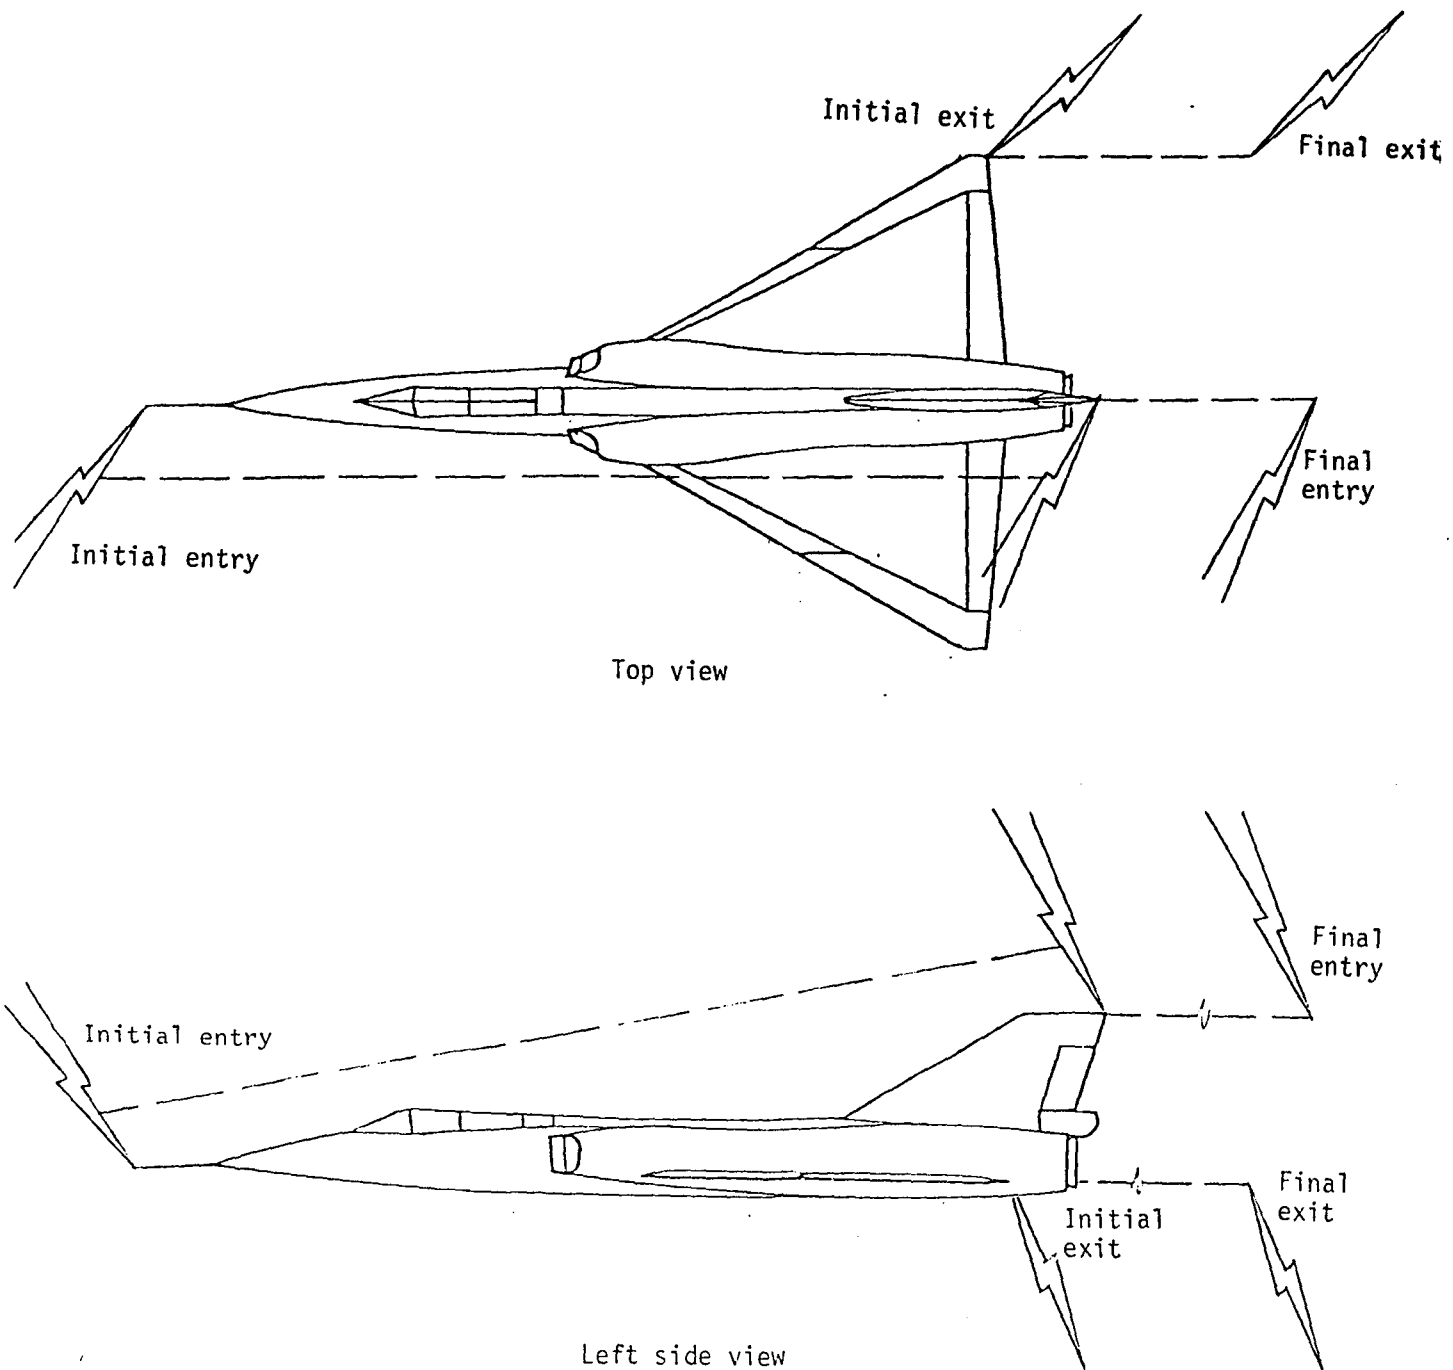
Figure 56.- Lightning attachment point scenario for strike 19, Flight 82-020.

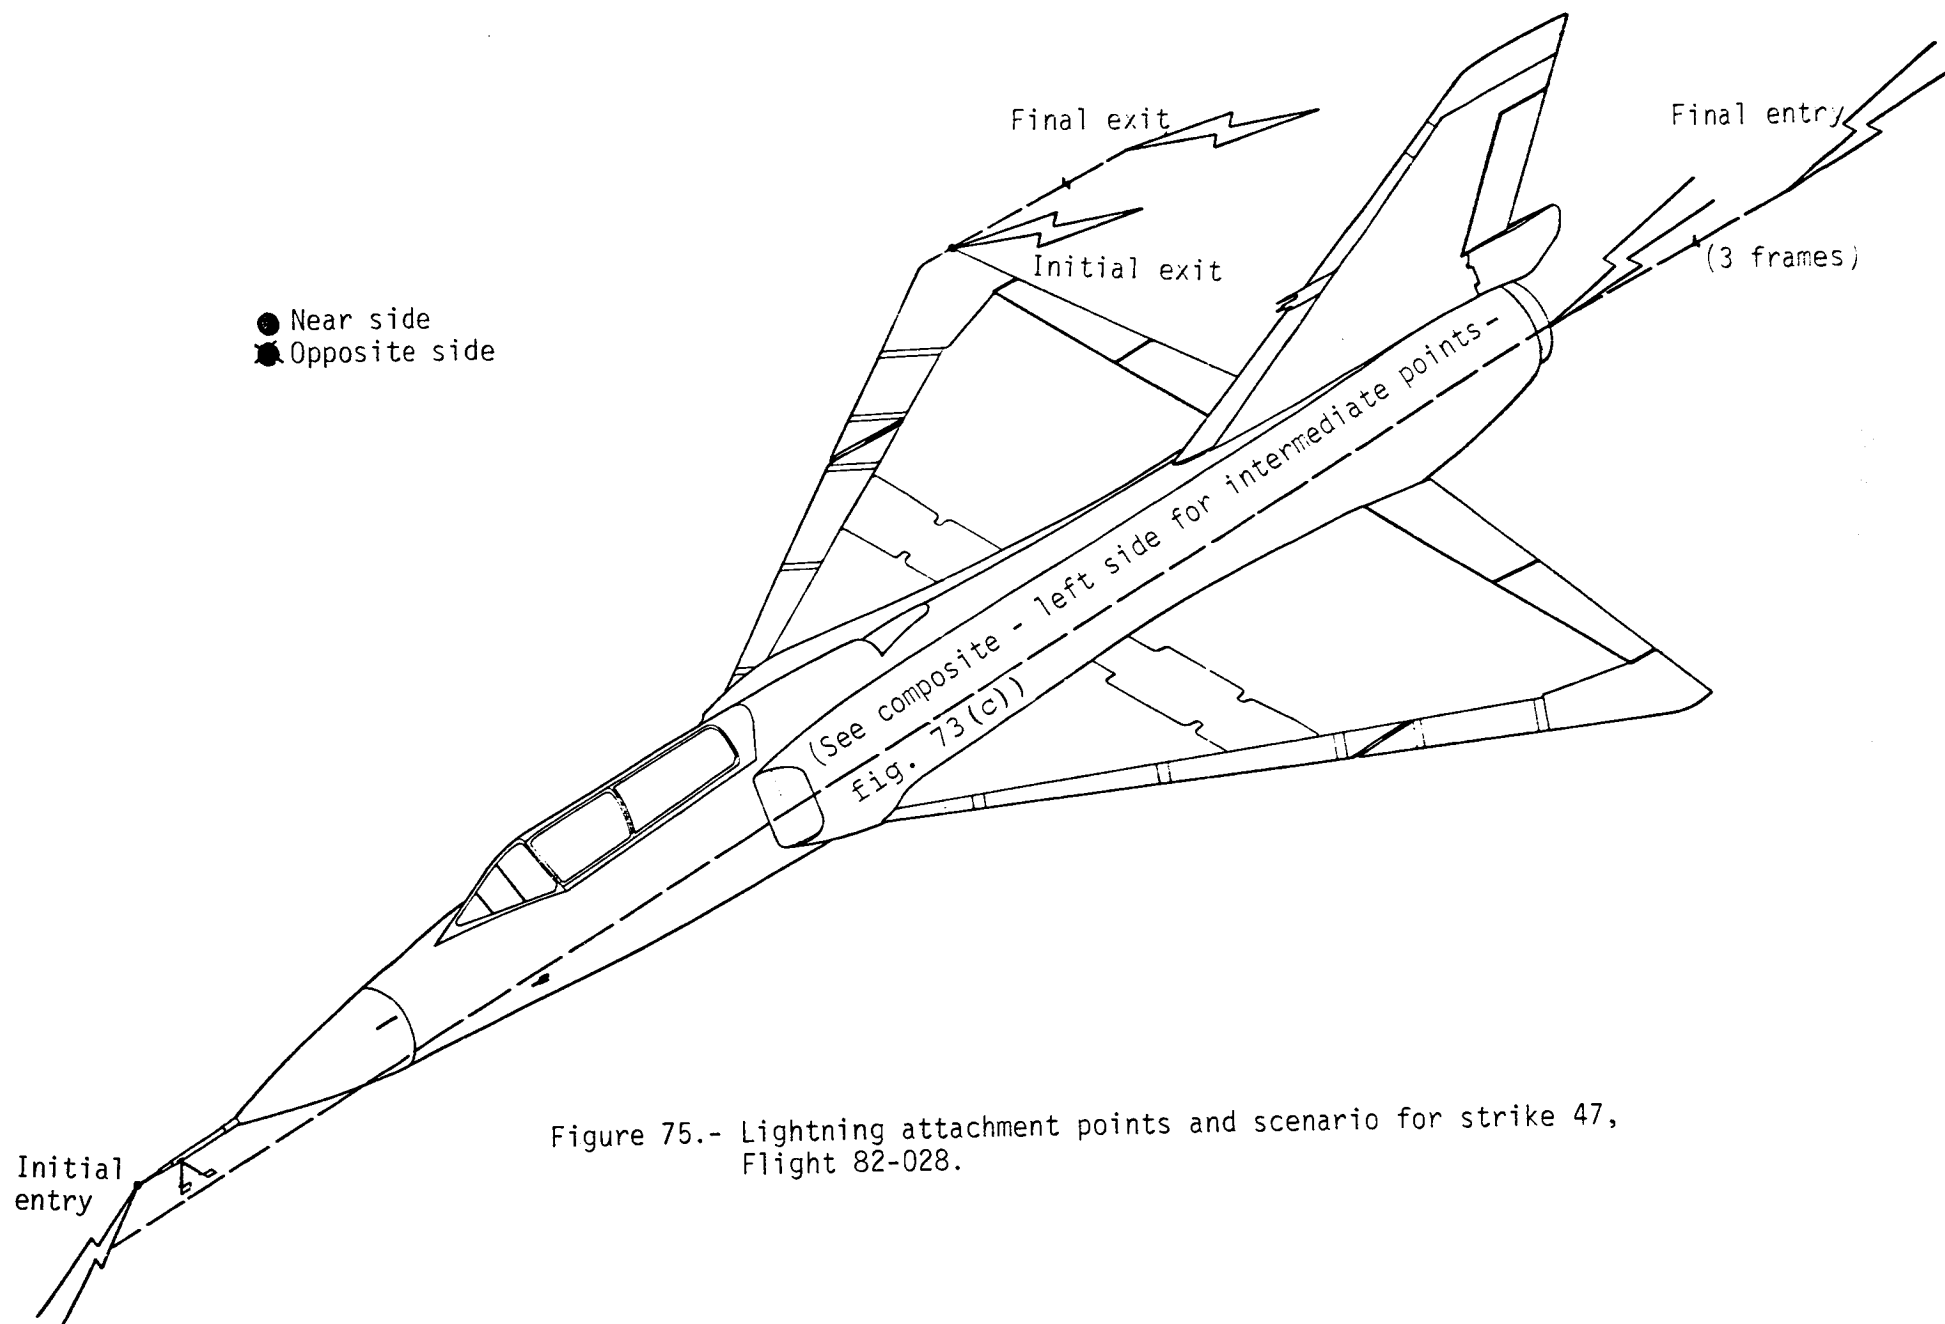
Figure 75.- Lightning attachment points and scenario for strike 47,
Flight 82-028.
